I'm gonna try to document the entire process in one post, with pictures and 2 linked files.

Demco's install manual was pretty skimpy. E-Trailer (and others) have good videos as to how to take the fascia off, and the Demco install manual shows it pretty clearly. The manual online is from 6/23 and does not reflect some issues I and another brought to Demco during our September 2023 installs.

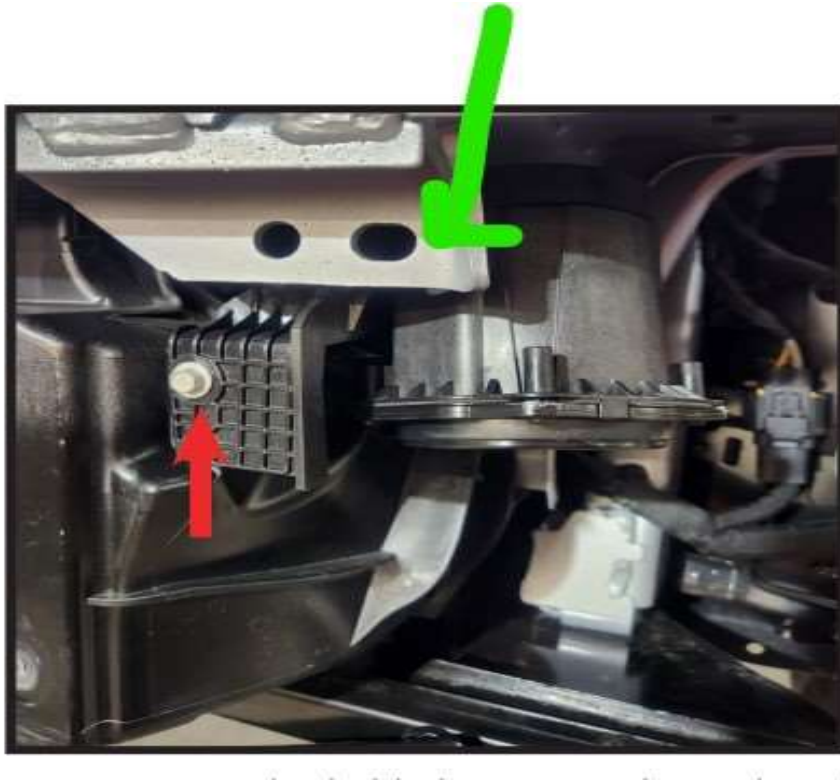
Step 7: Shows the PAD which needs removal. It also shows a better location to put it back as noted below in step 14. I used the green hole to re-mount it instead.

Step 14: No, No, No. When you try to reinstall the PAD (with the new 3/8" hole), you will realize 2 things. 1. The bolt/nut Demco provides is too short to add the PLASTIC PAD mount, so you would have to go get a longer bolt. 2. Once I did that, I then realized that putting that plastic in the bolt-brace-bracket-nut assembly, and then torquing it to 50 ft-lbs, was a recipe for failure. I did not want to torque a plastic sandwich. If you look at step 14 closely, you will see a hole in the upper left of the picture (actually 2 holes). The existing hole in the PAD will allow you to re-mount it right there in that outer hole. I used a small bolt and nyloc nut from my junk drawer to mount it in that hole.

Step 15: Notice that the plastic PAD mount shown in step 14 is not anywhere in Demco's picture!

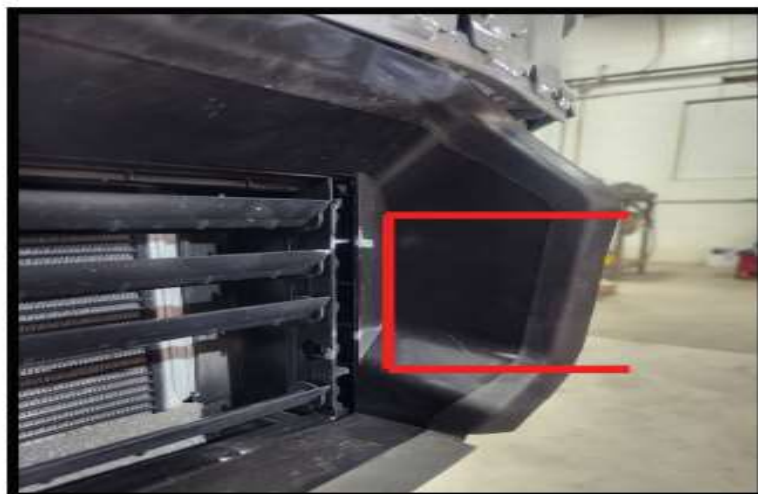
Step 8: This shroud is removable to work on. Release the 8 clips that hold it onto the truck. You see the area that needs to be cut out. This item is a plastic oval, with a rubber outer edge. What I did was to cut a slit in the rubber on each side and then cut out the plastic to make room for the baseplate bar. Thus the rubber still seals the airspace as intended. Not a problem to make a cut of both the plastic and the rubber like Demco shows, I just wanted to be a little neater:

8. Cut the air dam as shown on both sides of the vehicle.

I removed the baseplate and completed the shroud cutting at this point. You might be able to leave the baseplate in place and twist the shroud into position after cutting. I did not try that, but it might save a little time. Just remember to go back and put locktite on the threads and torque the bolts, once you are happy to leave the baseplate installed.

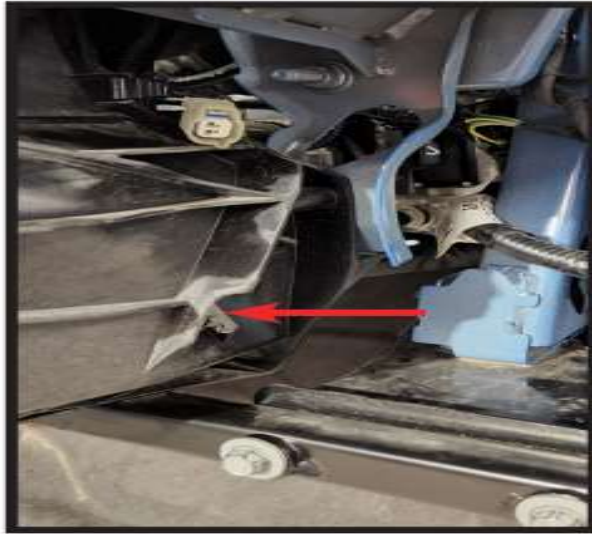
WHILE the shroud is off, do step 9 and step 10:

10. On the drivers side, trim off the air cooler wing as shown in the picture above. Some trimming may be needed. The passenger side may need to be trimmed as well.

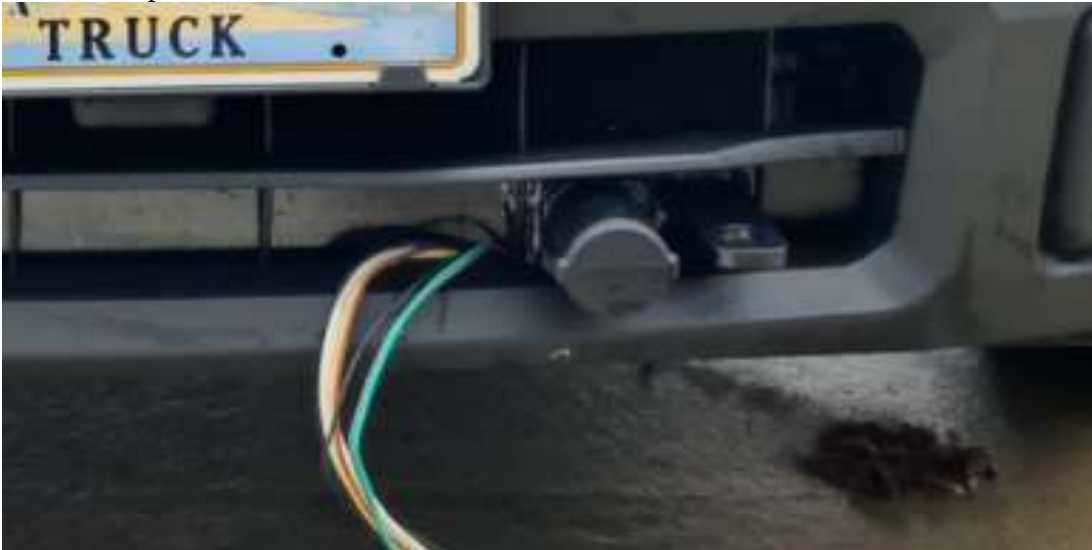
Putting the fascia back on is simple, just make sure the lower pieces are meshed together properly. The electrical will be a pain to decide where and how to install it. Notice that Demco's final picture has NO Electrical showing at all. They included a way-too-big and heavy 6-pin mount. I bought a lighter one. I ran the wires down the driver's side underneath, so they came out in the cutout area of the shroud while I finished up.
