# Rear Sliding Window Replaced, Still a Water Leak Same Area.

Rear sliding window water leak into cabin at driver's side lower corner..

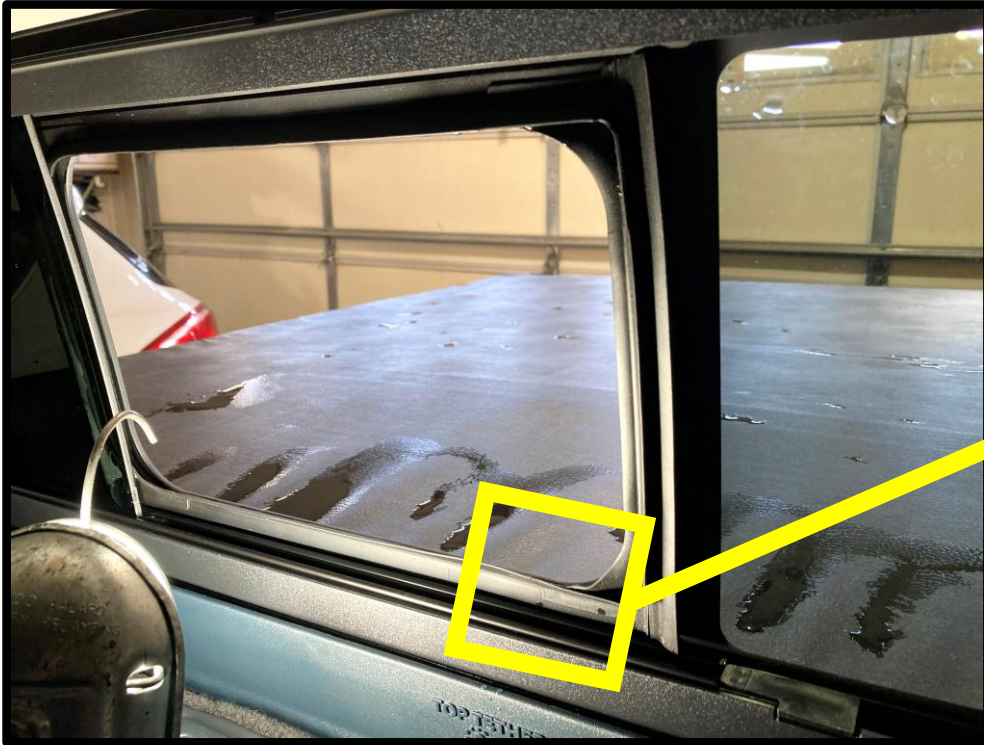
Photo taken from inside of cabin, on drivers side rear seat looking towards rear right truck tail light. Power window open.

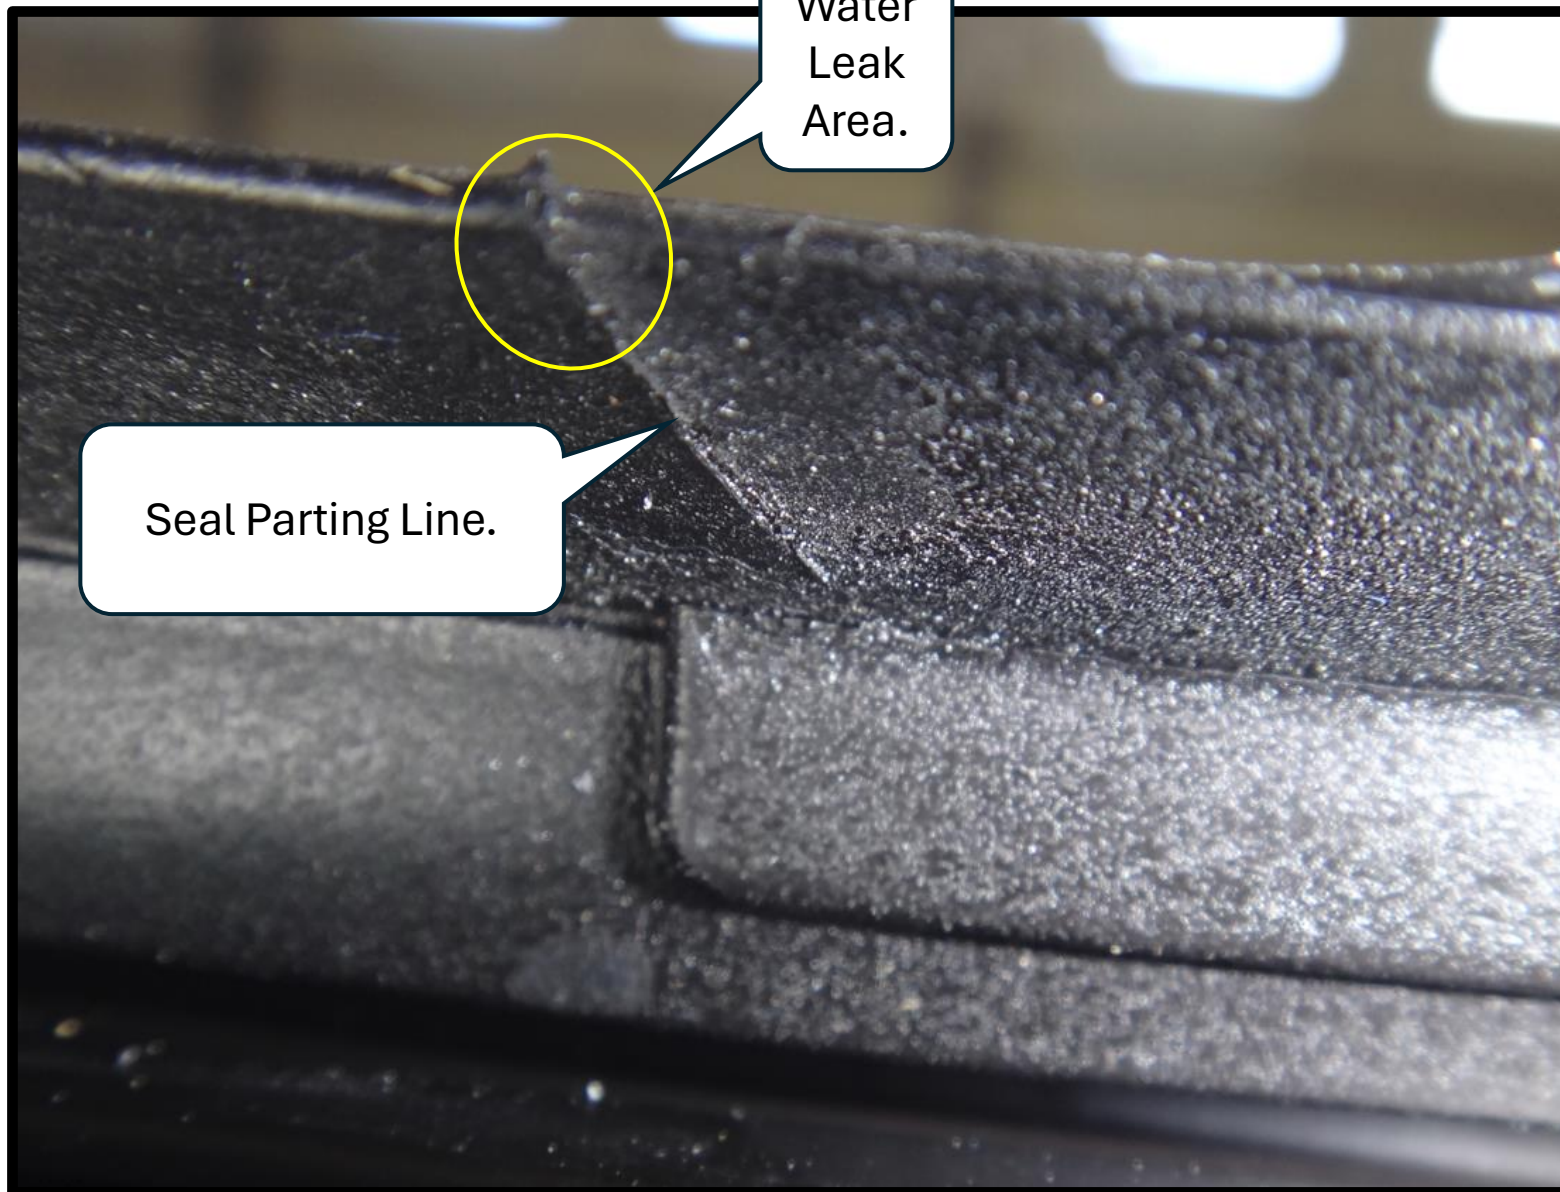
Zoomed in  
area, see  
previous  
page.

Water  
Leak  
Area.

Seal Parting Line.

It appears that many if not all seals have mold parting lines that may leak. Replacing the window did not fix leak in my case. The design or reworking the mold that makes the seal is needed to fix the problem or the factory polishing the surface to ensure no bump in parting line.

My fix was to lightly sand with 15 micron (very fine) sandpaper the parting line in the seal and apply dielectric grease to fill in any scratches or voids in the molded rubber seal.

You just want to flatten out the angled parting line both on the left and right side of the window (see pages 2&3). Apply dielectric grease to the top edge and the inside 1/4 inch from top of seal all way from left to right where it rubs against the sliding glass (see page 6). Key here is the dielectric grease (any brand). You need very little, like a pea size or less, and apply it once or twice horizontal across the seal lip with finger with window open.

1. Root cause of the issue is that the window rubber seal has parting lines (page 2&3) which allow a water passage to seep from outside to inside of cabin.

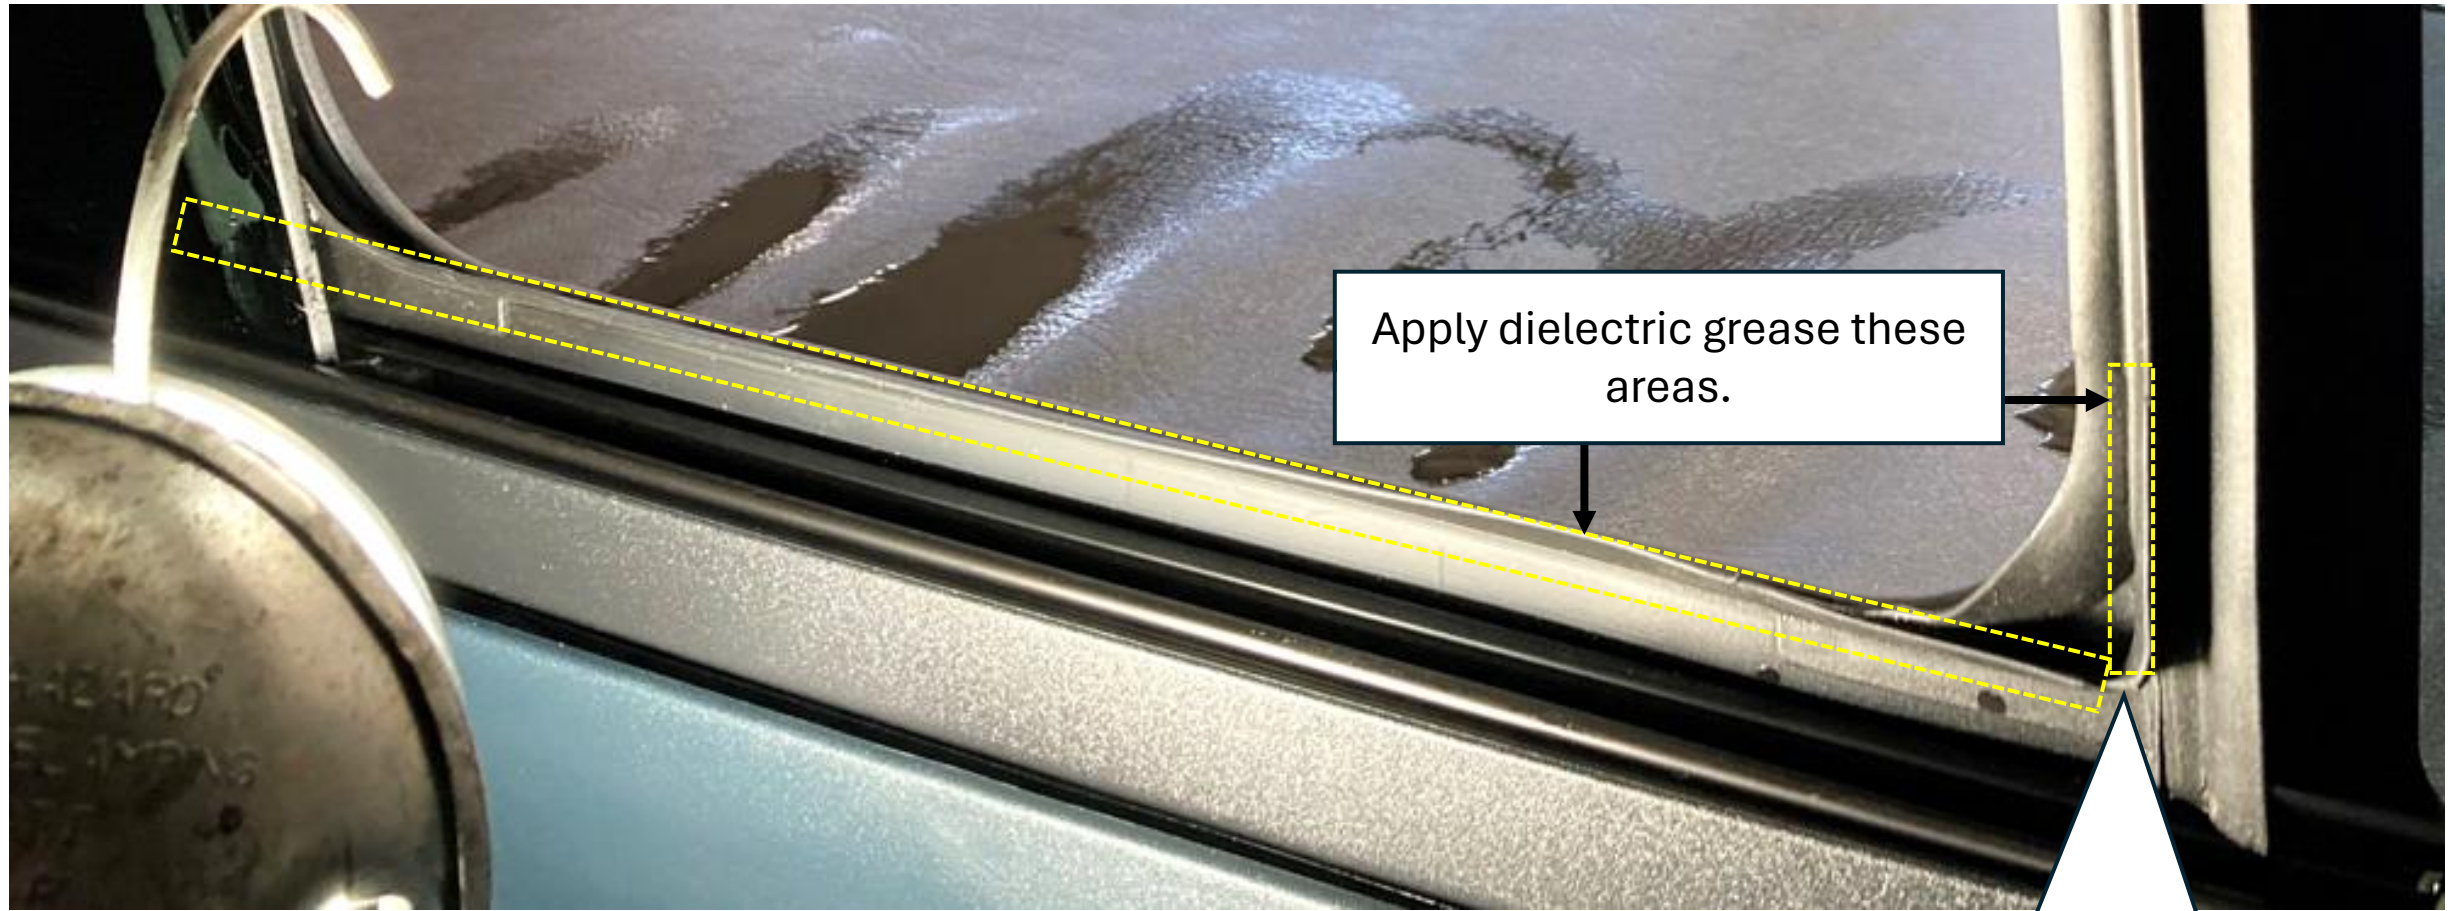
Area where to apply the dielectric grease:

Apply dielectric grease these areas.

Make sure corner is covered with grease.

2. Lightly hand sand (stroking left to right, not up and down) with fine grit paper to flatten the parting seam in rubber seal.
3. Apply light coat of dielectric grease to the upper section of the seal where it contacts the sliding glass (page 6). Make sure to add the grease to the bottom sealing corner since the corner pocket fills with water.

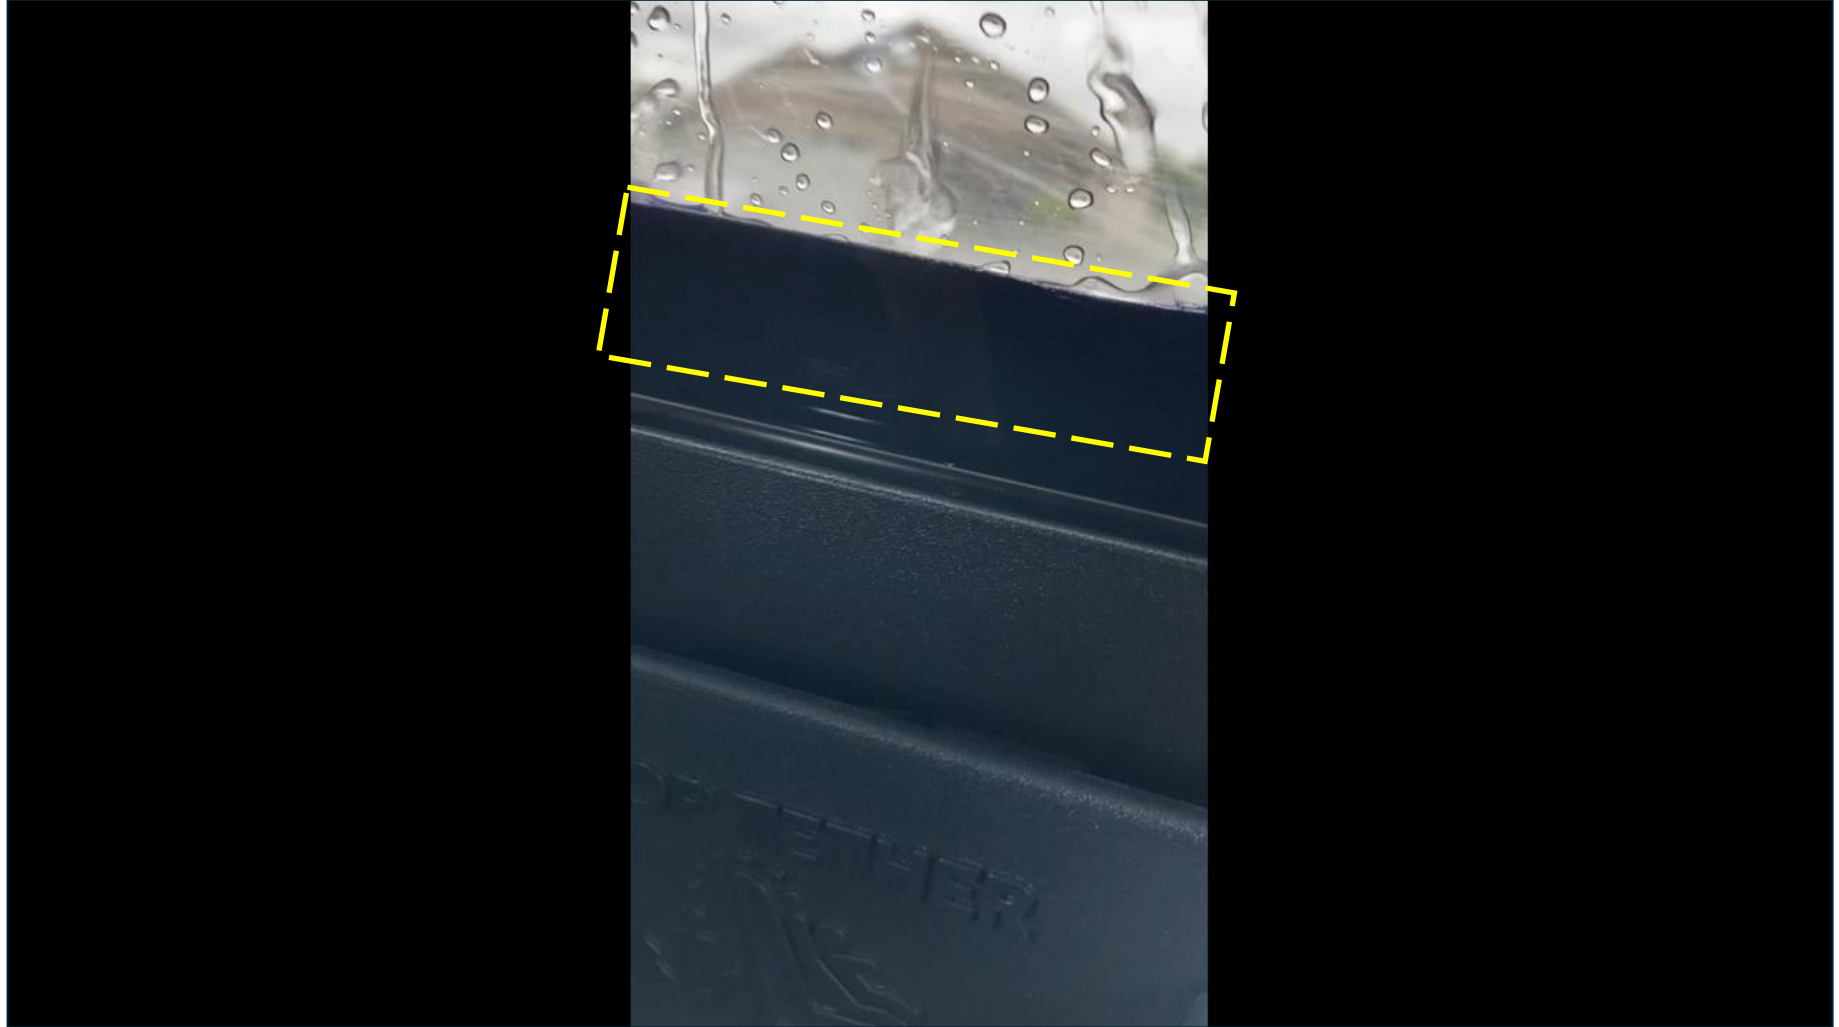
No leak anywhere on seal, key is a thin layer of dielectric grease on seal where it contact sliding glass as shown on previous page. Remove any high spots with fine sandpaper first. A quick test with a water hose will quickly reveal leaks and to ensure you have a good fix. Use flashlight in the cabin to better see if any leak exists:

Click on  
picture  
and  
then  
play  
here.
