| General Service Bulletin (GSB): | Gas Engine Performance Modifications |
| GSB Overview: | This bulletin will assist the dealer in identifying engine related modifications. |

## **A Guide to Identifying Failures Related to Performance Modifications**

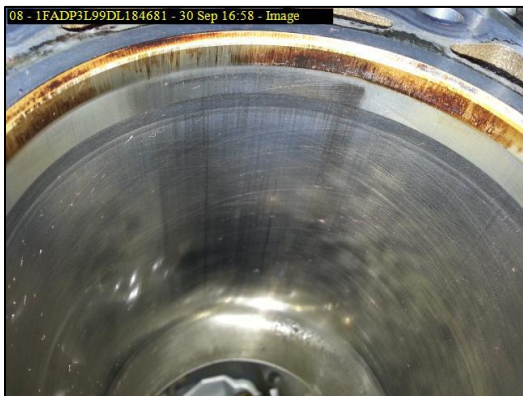
Figure 2: Scored Bore Walls

**Description:** Damage to piston profiles can often be attributed to pre-ignition (knock) events. OEM calibrations will protect the engine from pre-ignition damage by retarding spark. Aftermarket calibrations will typically change timing schedules and allow the engine to run closer to damage limits. Pre-ignition along with extreme air-fuel ratios and excessive oil consumption may also damage catalyst material. This material can then be pulled back into the engine, scoring the cylinder bore walls.

- Aftermarket calibration (Sec. B.1)
- Turbo modifications (Sec. C.2.1)
- Exhaust system modifications (Sec. C.1.5)
- Catalyst Damage
- Low Quality Fuel

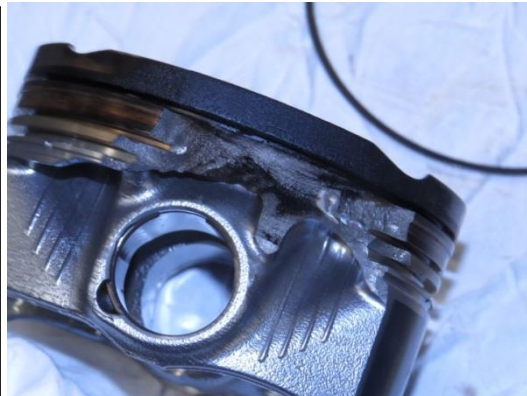
Figure 3: Piston Ring Land Damage

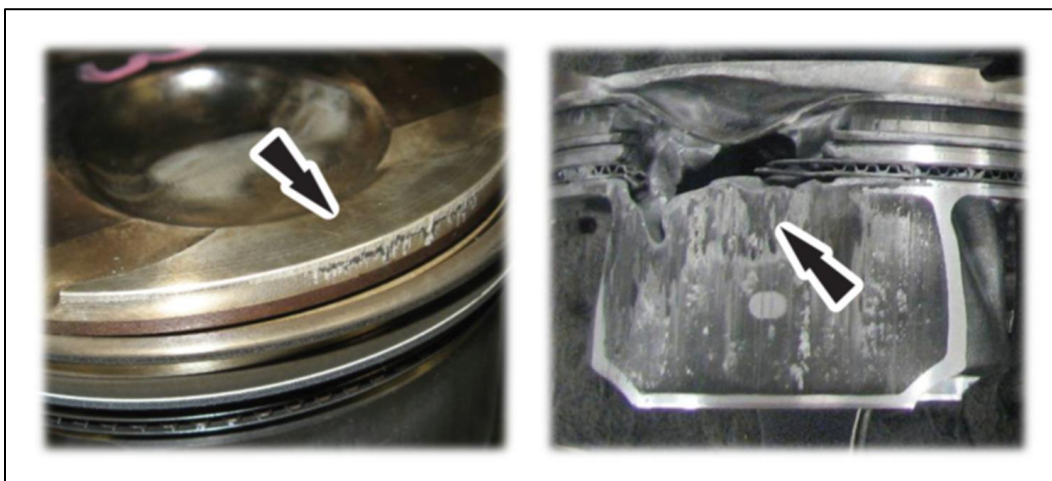
Figure 4: Light/Heavy Knock Damage

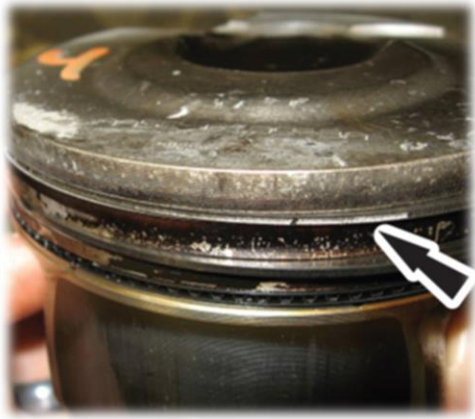
Figure 6A: Piston Ring Damage

**Similar to the piston damage in section A1.1,** damage to piston rings can also be attributed to pre-ignition (knock) events. OEM calibrations will protect the engine from pre-ignition damage by retarding spark. Aftermarket calibrations will typically change timing schedules and allow the engine to run closer to damage limits. Damage to the top piston ring may exhibit in the form of delamination, pitting or fracture.

- Excessive spark advance from aftermarket calibration (Sec. B.1)
- Excessive spark advance from changes in induction system (Sec. C.1.2)

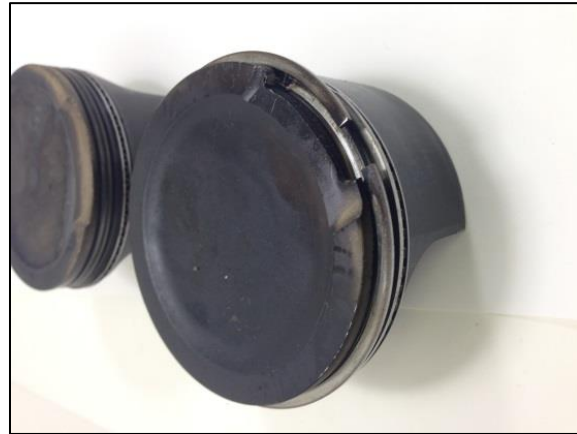
Figure 6B: Ring Land Damage

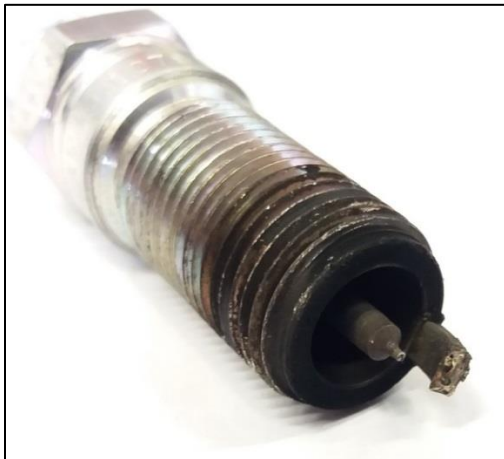
Figure 7A: Spark Plug Ground Electrode Damage

Spark plug damage as shown in Figures 7A and 7B can be another indicator of an aftermarket calibration, changes to the vehicle induction system, or other revisions that can increase combustion temperatures. This is especially true when the plugs show rapid degradation in all cylinders as in Figure 7B.

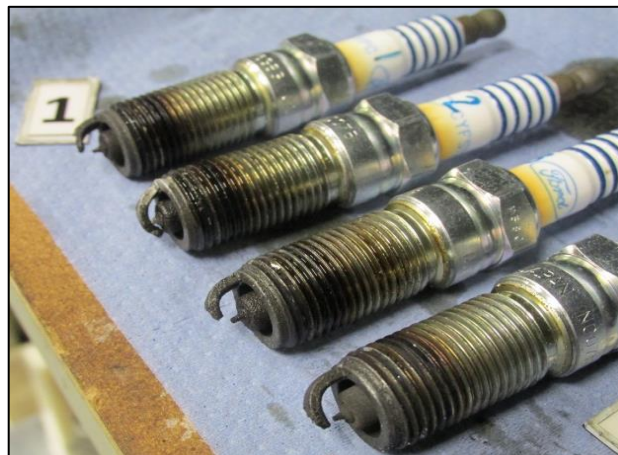
Figure 7B: Spark Plug Damage and Abnormal Color

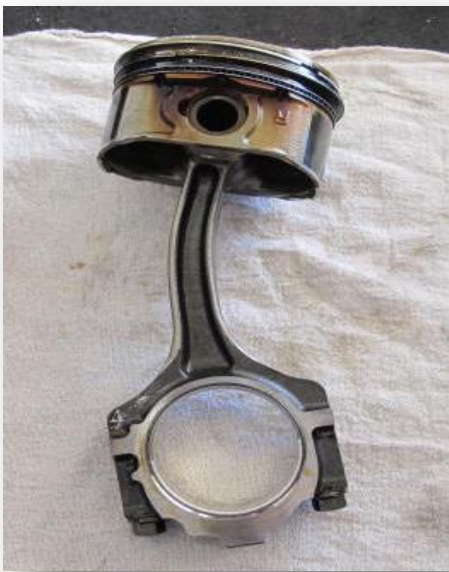
Figure 8: Bent Connecting Rod from Hydro lock

**Description:** Hydrolock occurs when a volume of liquid greater than the smallest volume of the combustion chamber enters the cylinder and becomes incompressible as the piston reaches Top Dead Center. The result is most commonly a bent or broken connecting rod. Connecting Rod damage may also be caused by excessive cylinder pressure (overboost condition) and may not be obvious via visual inspection. Connecting Rod twisting can lead to bore scoring and eventual piston failure. Note that connecting rod bends or twists may not be obvious visually, but can still contribute to engine damage or failure.

- Leaking Fuel Injectors (Sec. C.1.6)
- Rerouted air induction systems that show evidence of water injection (Sec. C.1.2)

- Turbocharger modifications (Sec. C.2.1)
- Supercharger modifications (Sec. C.2.2)

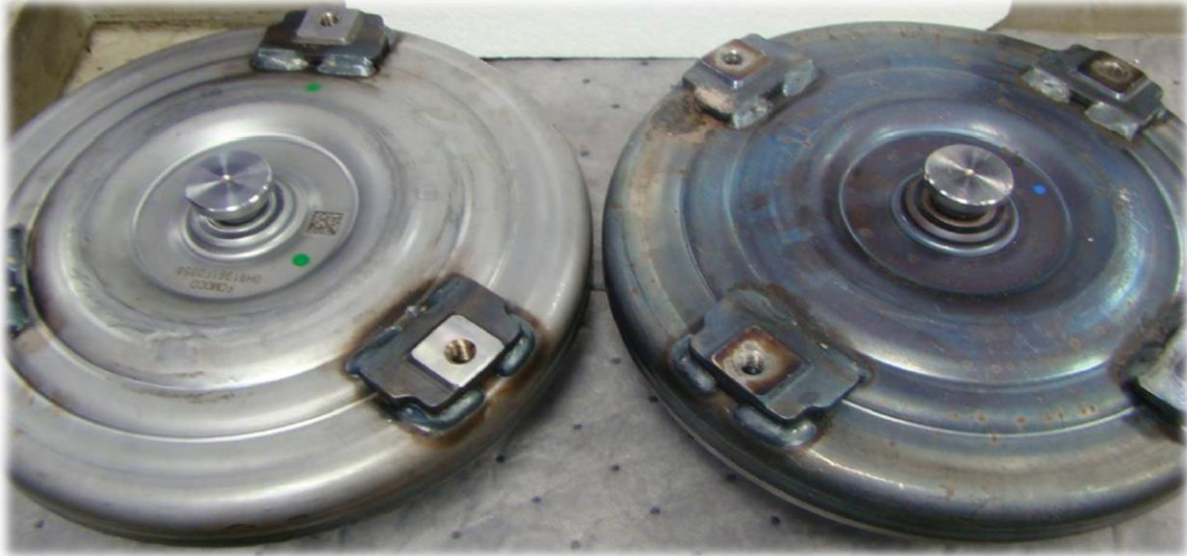
Figure 9: Left - Normal TC | Right - Overheated TC

**Description:** Overheated torque converters will exhibit discoloration.

- Any aftermarket modification that increases torque or power output may cause the torque converter to overheat.

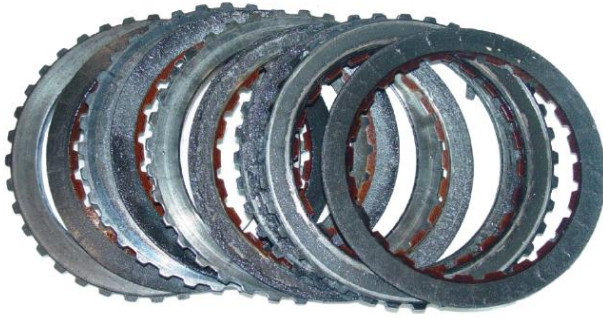
Figure 10A: Damaged Clutch Discs

Figure 10B: Damaged Separator Plate

**Description:** Clutch damage can present itself in many forms including discoloration, cracking, and warping of the clutch discs and separator plates.

- Any aftermarket modification that increases torque or power output may cause damage to the clutch system.

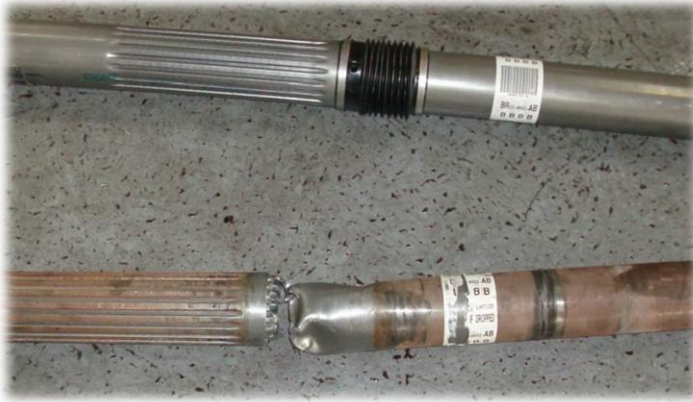
Figure 11A: Twisted Driveshaft

**Description:** Twisting of the driveshaft is commonly associated with increased torque output.

- Any aftermarket modification that increases torque or power output may cause damage to the driveshaft.
- Soft compound race tires (often identified by rubber built up in wheel well) combined with hard launches.

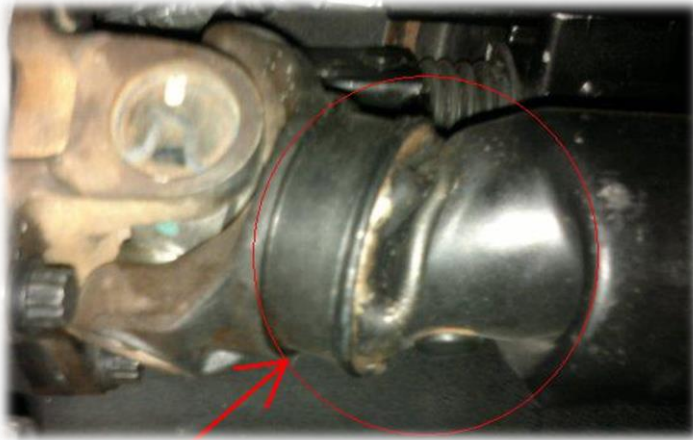
Figure 11B: Twisted Driveshaft

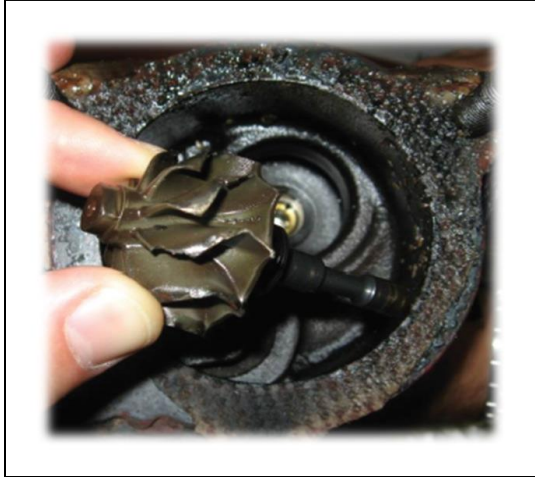
Figure 12: Compressor Blade Damage from Overspeed Event

**Description:** Turbo compressor damage is commonly identified by broken or deformed turbine blades.

- Aftermarket calibration (Sec. C.1.1)
- Wastegate modification (Sec. C.2.1.1)
- Exhaust system modification (Sec. C.1.5)

- Air induction system modification (Sec. C.1.2)
  - Cold air intake
  - Throttle body spacer
- Blow off valve (Sec. C.2.1.2)

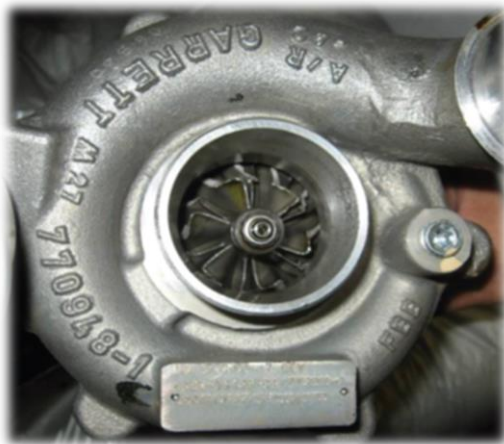
Figure 13: Compressor Blade Damage from Overspeed Event

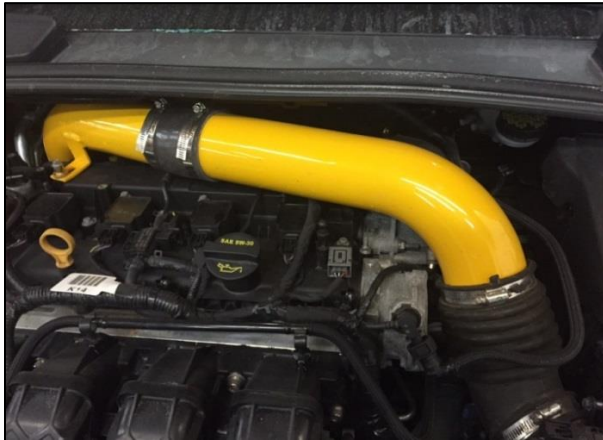
Figure 16A: Aftermarket Air Intake

**Description:** Modifications to the air intake system may include aftermarket air boxes, filters and low/high pressure air ducts. The system may be particularly susceptible to flexible air ducts between the air filter and the compressors. Restrictions on either side of the compressor can result in over-speeding the turbo in forced induction engines. Aftermarket air induction systems may cause lean air-fuel ratio DTC's (P0171 & P0174).

- Turbocharger Compressor Damage (Sec. A.2.1)
- Catalyst Damage
- Piston Damage from Detonation (Sec. A.1.1)

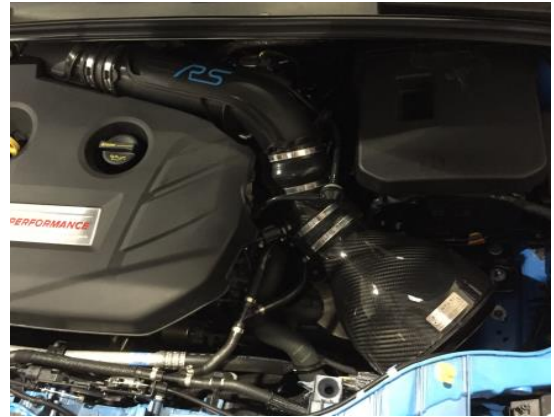
Figure 16B: Aftermarket Air Filter Setup

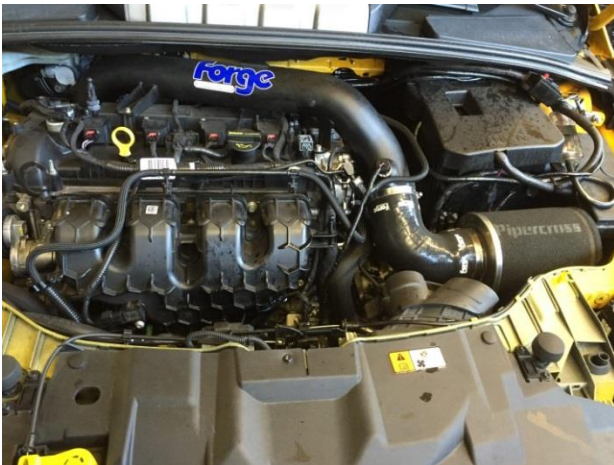
Figure 16C: Aftermarket Air Intake and Air Filter

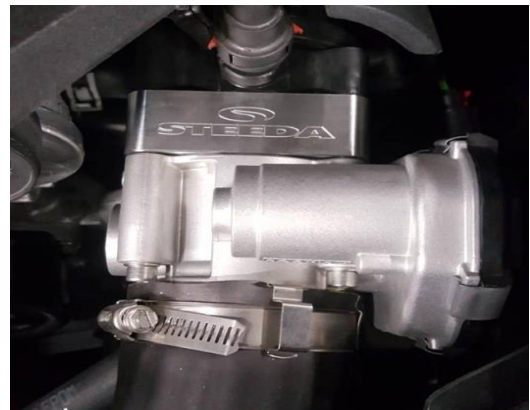
Figure 16D: Aftermarket Air Induction setup

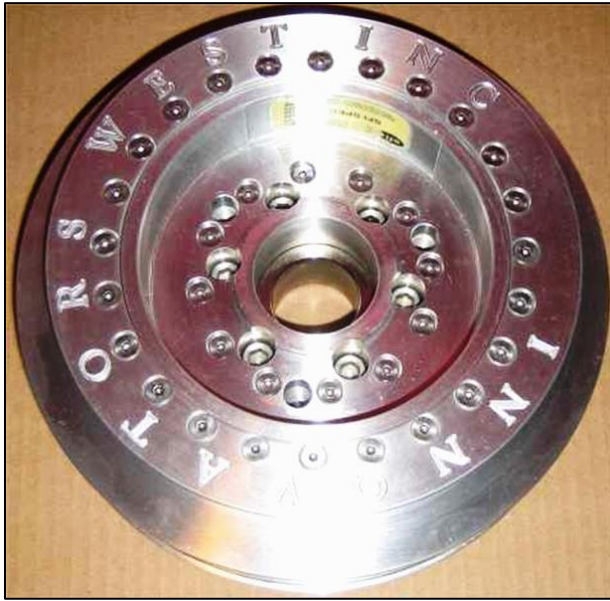
Figure 18: Aftermarket Crankshaft Pulley

**Description:** Overdrive pulleys are intended to spin faster than OEM pulleys. On forced induction engines they may increase boost pressure which can lead to an overboost condition and subsequent engine damage. Most aftermarket pulleys are machine finished, where OEM pulleys are painted a dull black. Examine the stock pulley bolt for signs of tampering.

- Piston damage (Sec. A.1.1-A.1.2)
- Driveshaft damage (Sec. A.1.6)
- Clutch damage (Sec. A.1.5)
- Oil Pump damage

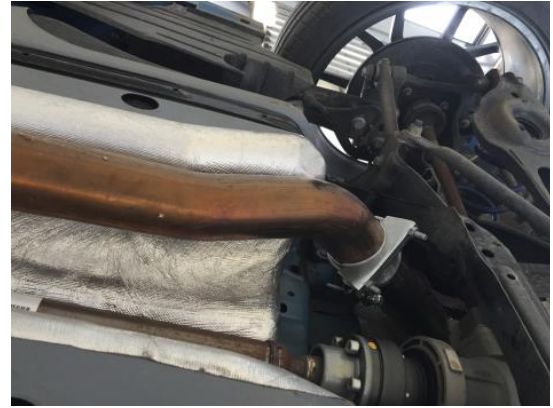
Figure 19B: Aftermarket Exhaust –clamped pipe

**Description:** Common modifications include the removal of catalysts, mufflers and resonators. In turbocharged applications modifications to the exhaust system can reduce backpressure and may result in over-speeding the turbo(s). In some cases a good indicator of an aftermarket exhaust is the presence of additional clamps (Figure 19A and 19B). Visually compare installed exhaust to pictures of OEM exhaust, if necessary.

- Turbocharger compressor damage (Sec. A.2.1)
- Exhaust smoke due to change in system backpressure
- Piston damage (Sec. A.1.1-A.1.2)

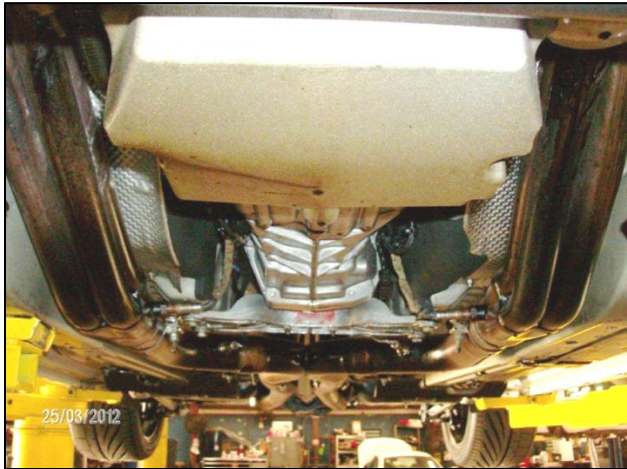
Figure 19C: Long Tube Headers - Catalyst Delete and "X" pipe

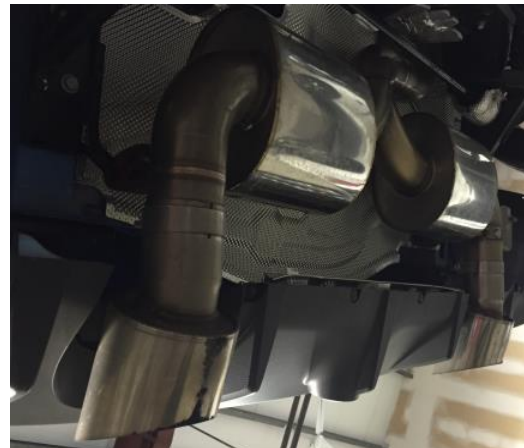
Figure 19D: Aftermarket Exhaust

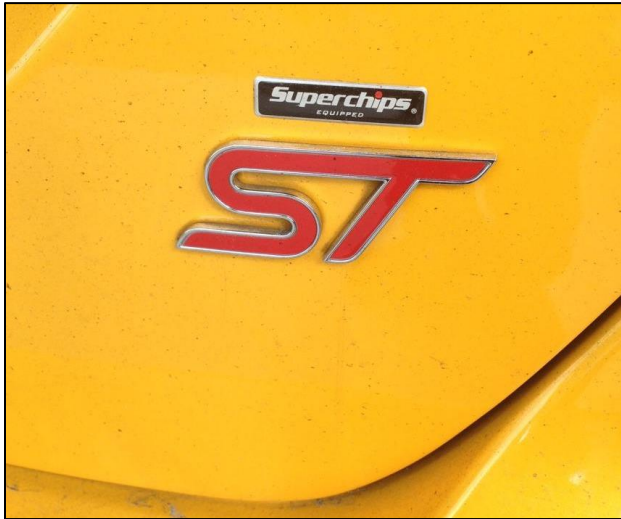
Figure 20: Aftermarket Badge

- Indicator of possible aftermarket modifications present
  - Inquire with customer as to existence of said aftermarket parts

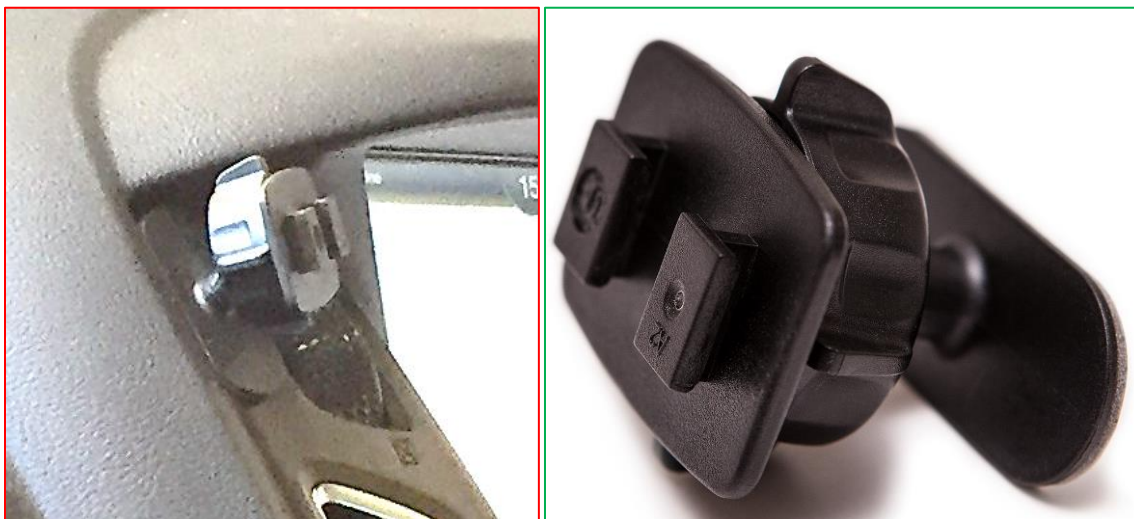
Figure 21: Dash Mounts for Tuner Handhelds

- Indicator of possible aftermarket calibration
  - Inquire with customer regarding purpose of mount and refer to Section B for checking for presence of aftermarket calibration.

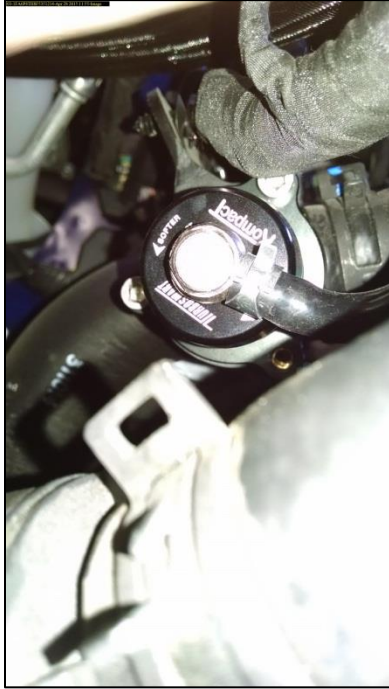
Figure 23: Typical Blowoff Valve

**Description:** Blowoff valves relieve intake manifold pressure to prevent turbo compressor surge. When the pressure is released a distinct hissing sound can be heard. Blowoff valves are often tuned for their auditory effect. In doing so, the amount of pressure relieved from the system can change leading to compressor surge.

- Turbocharger Compressor Damage (Sec. A.2.1)

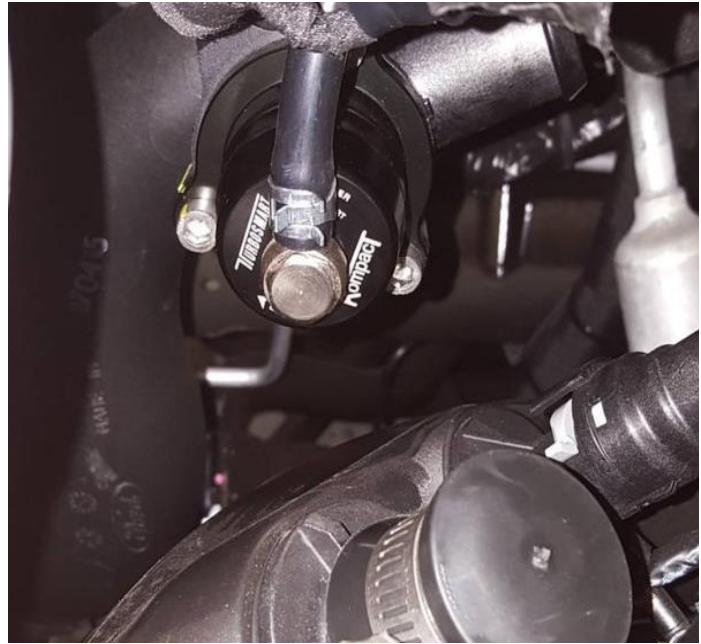
Figure 24: Compressor Bypass Valve

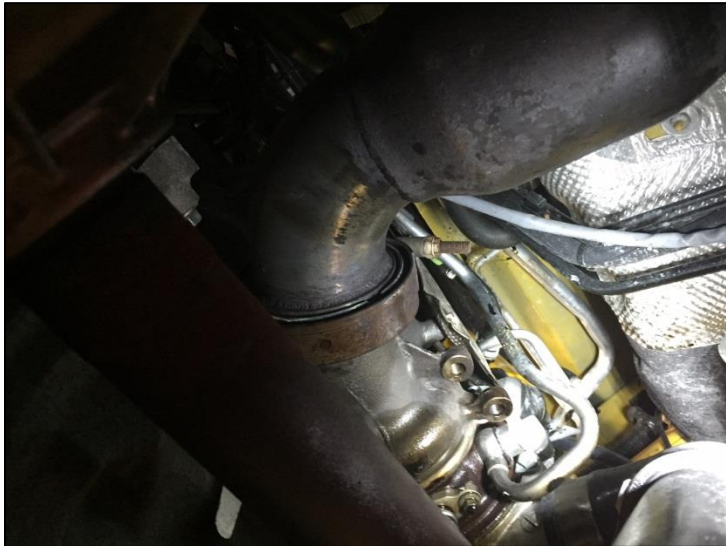
Figure 25: Down Pipe

**Description:** A downpipe is an unrestricted section of exhaust directly downstream of the turbo. By unrestricted the flow, the turbo may be able to spool up faster, reducing turbo lag. However, unrestricted the flow of exhaust can change the backpressure in the system which can lead to over-speeding the turbo.

- Turbocharger Compressor Damage (Sec. A.2.1)
- Piston damage (Section A.1.1 – A.1.2)
- Exhaust smoke from turbocharger seal leakage

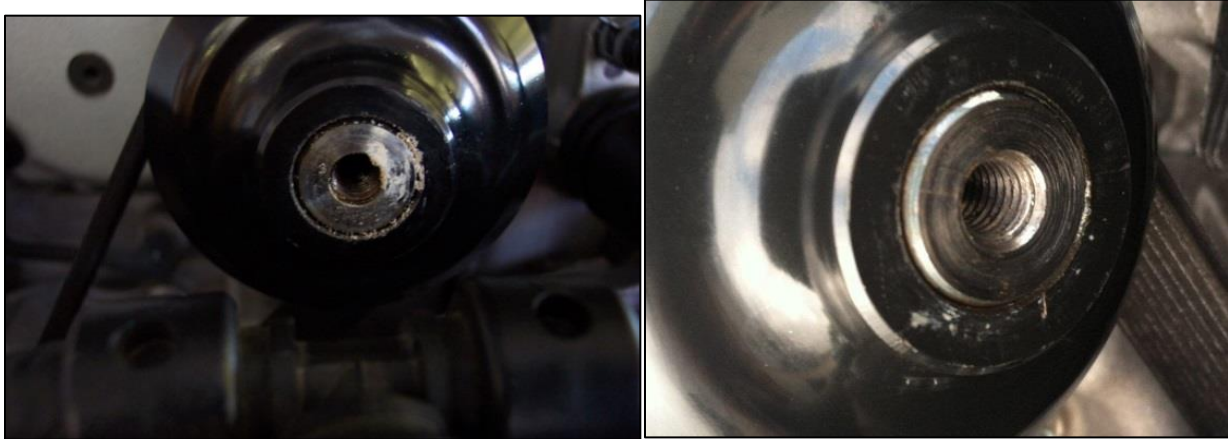
Figure 26: OEM Drive Pulley | Left: Untampered | Right: Tampered With

**Description:** Customers may modify or replace supercharger drive pulleys to increase supercharger speed and associated boost pressure. Customers may reinstall the OEM drive pulley before bringing the vehicle in for repair. Figure 26 shows both untampered and tampered with pulleys. On the left side of Figure 26, note the white anti-tamper compound and smooth face of the supercharger shaft. The black plastic cover is a Christmas tree style and can be removed by unscrewing it from the blower shaft. On the right side of Figure 26, note the white anti-tamper compound is almost all removed and is misaligned (12 o'clock on shaft and 3 o'clock on pulley). Gall marks on the face of the blower shaft and scuff marks on the face of the pulley indicate use of a puller to remove the pulley and a press tool to reinstall the pulley. The most common change is a smaller diameter drive pulley to increase boost by spinning the supercharger at higher RPMs. This modification also requires an aftermarket calibration. The OEM pulley diameters are 3.0 inches for the 5.4L and 2.7 inches for the 5.8L. Aftermarket pulleys are available in various sizes smaller than these diameters and may visually appear to look exactly like OEM stock pulleys.

- Piston Damage (Sec. A.1.1-A.1.2)
- Clutch Damage (Sec. A.1.5)

- Driveshaft Damage (Sec. A.1.6)

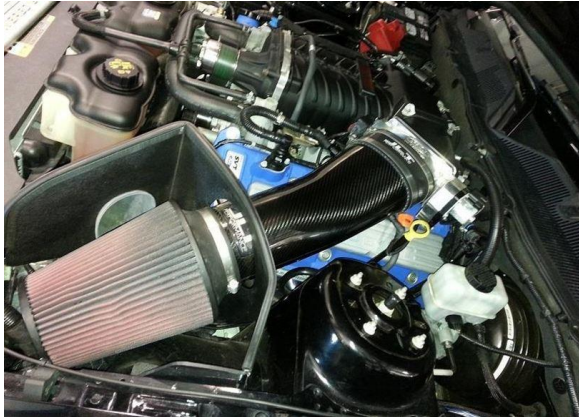
Figure 27: GT500 Aftermarket Air Filter, Inlet Tube, Throttle Body & Supercharger

**Description:** Adding aftermarket superchargers can stress the engine beyond design limits through increased torque and power outputs and cause numerous failures. Changes in the induction system such as aftermarket throttle bodies and inlet tubes can cause changes in air-fuel ratio that leads to piston damage. These modifications should be easily visible. Most aftermarket superchargers will have a custom surface finish (polished or wrinkle black).

- Piston damage (Sec. A.1.1-A.1.2)
- Clutch Damage (Sec. A.1.5)
- Driveshaft damage (Sec. A.1.6)

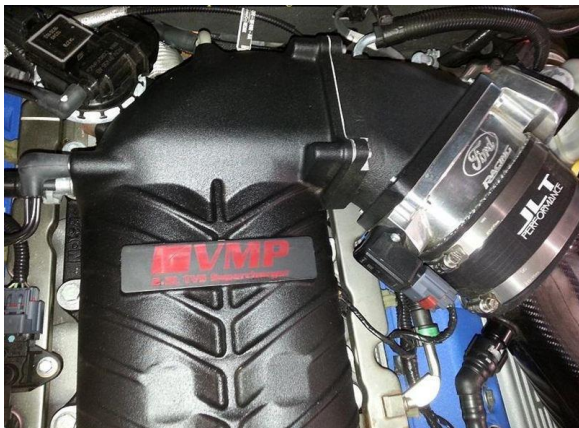
Figure 28: GT500 Aftermarket Supercharger & Throttle Body
